Manhole Inspection Summary

Manhole # S29K__044MH

Location Address: **314-669 Melvin Dr**

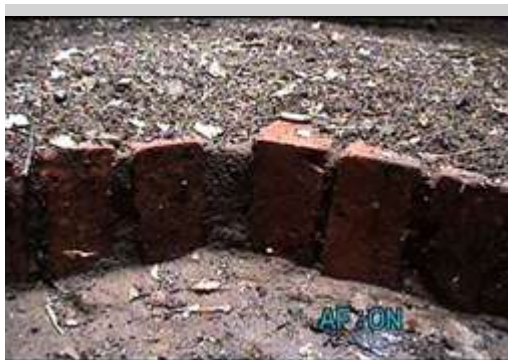
Defect 4

Condition: ☐ Sound ☐ Cracked ☐ Root Intrusion ☐ Deteriorated ☐ Leaks ☒ **Debris**

bench debris

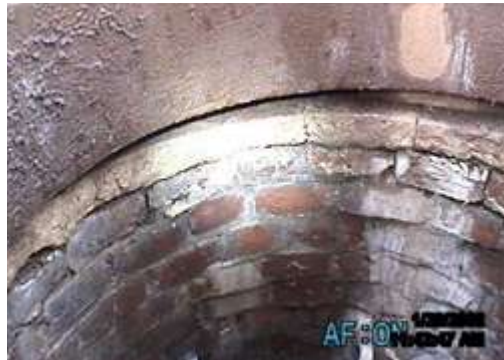
Defect 3

Frame Offset: **2** (in.) Condition: ☐ Sound ☐ Cracked ☒ **Leaks**

Infiltration: ☐ None ☒ **Joint** ☐ Cracks ☒ **Mortar** ☐ Roots ☐ Wall

frame infiltration from cover, chimney
infiltration from frame joint and mortar

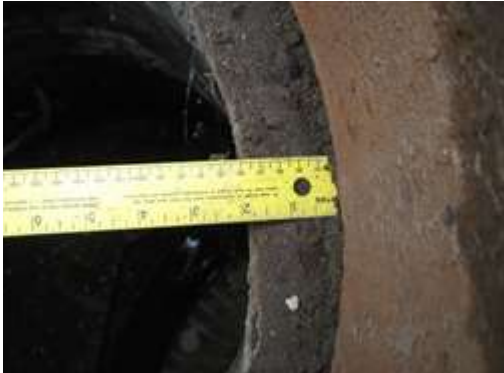
Defect 2

frame offset 2 inches

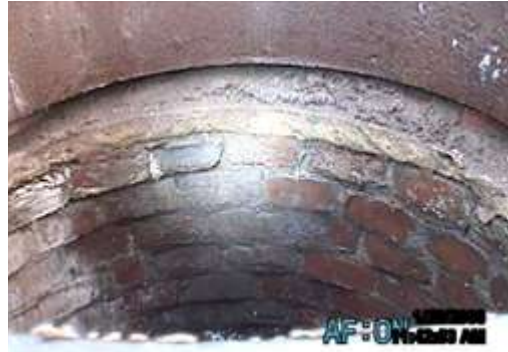
Defect 1

Condition: ☐ Sound ☐ Cracked ☐ Root Intrusion ☐ Loose Brick ☒ **Deteriorated**

chimney deteriorated

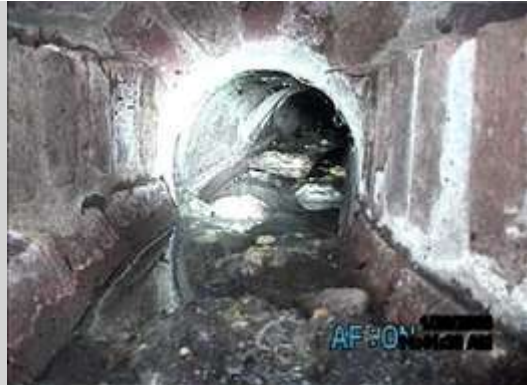
12 O'Clock Outflow

Pipe Height: **8.4** (in.) Rod and Bar (Angled)
Pipe Material: **Clay** ☐ Pipe Lined
Invert Depth: **7.90** (ft.) Flow Characteristics: **Slow**
Deposits: ☐ None ☐ Mud ☐ Sludge ☒ **Debris** ☐ Grease
Silt Depth: **0** (in.) Deposits Extent: **Medium**
Infiltration: **None** Pipe Seal Cond: **Sound**

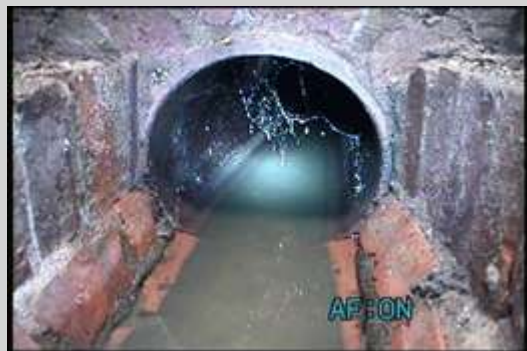
5 O'Clock Inflow

Pipe Height: **8.4** (in.) Rod and Bar (Angled)
Pipe Material: **Clay** ☐ Pipe Lined
Invert Depth: **7.80** (ft.) Flow Characteristics: **Slow**
Deposits: ☒ **None** ☐ Mud ☐ Sludge ☐ Debris ☐ Grease
Silt Depth: **0** (in.) Deposits Extent:
Infiltration: **None** Pipe Seal Cond: **Sound**
